Conduct of Steel Fiber Reinforced Concrete with Bottom Ash as Fine Accumulate to Heat Exposure

Mahmoud Khazalah

Department of Civil Engineering

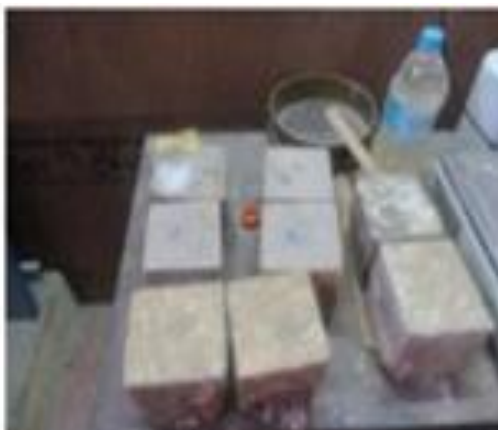
Figure 1.1

Appearance of the 3D square surface was seen subsequent to warming. It could be seen that following one hour of warming, the surface showed up somewhat blurred. This swung to a slight tanish tinge following two hours of warming, with a darker shade of light darker, after the third hour. (Fig 1.1-appearance of 3D shape surface) Hair line splits in an indiscriminate way were additionally observed on the surface of the cubes.(Fig.1.7, 1.8-breaks as saw on the surface of 3D shapes) On testing for compressive quality, it was watched that the quality relatively expanded for the second hour of warming, when contrasted and the first and third.(Fig.1.4,1.6) The outcomes are delineated in the table number 1.1

The 3D squares when warmed to 1000 degree Celsius under the different time term of presentation displayed extremely poor execution. It could be seen that a dark colored shading beat the surface. Low compressive quality esteems were recorded.(Fig. 1.2 – 3D square disintegrated on testing) After the third hour of warming, the 3D shape nearly disintegrated, even before use of the heap. This shows the solid can't withstand temperature as high as 1000 degree Celsius.(Fig.1.1, 1.3, 1.5-disintegrating of 3D squares while testing) The outcomes are arranged in Table number 1.2
